Manhole Inspection Summary

Manhole # S11O__006MH

Location Address: **405 S. Caton**

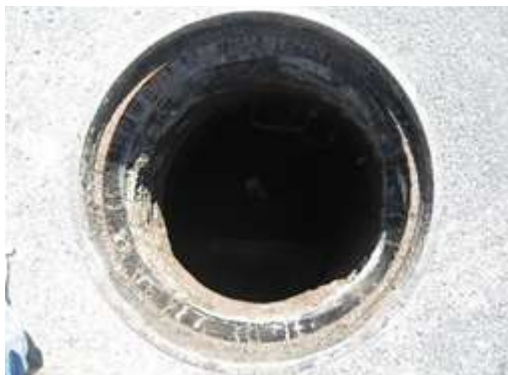
Frame View

Condition: ☒ Sound ☐ Cracked ☐ Leaks

Condition: ☐ Sound ☒ **Cracked** ☐ Root Intrusion ☒ **Loose Brick** ☒ **Deteriorated**

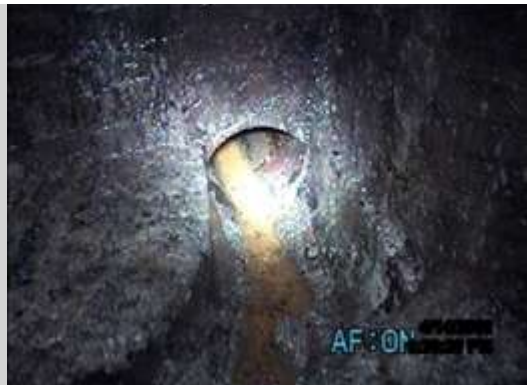
4 O'Clock Inflow

Pipe Height: **8.4** (in.) Rod and Bar (Angled)
Pipe Material: **Clay** ☐ Pipe Lined
Invert Depth: **21.75** (ft.) Flow Characteristics: **Fast**
Deposits: ☒ None ☐ Mud ☐ Sludge ☐ Debris ☐ Grease
Silt Depth: **0** (in.) Deposits Extent:
Infiltration: **None** Pipe Seal Cond: **Sound**

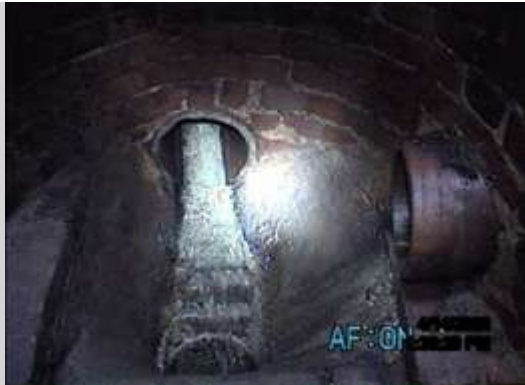
6 O'Clock Inflow

Infiltration: **None** Pipe Seal Cond: **Sound**

Drop: **Outside Direct**

Drop Condition: **Open**

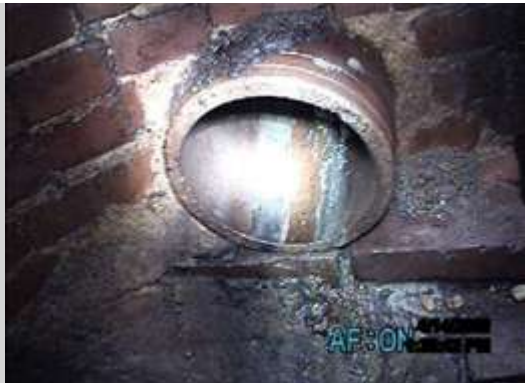
8 O'Clock Inflow

Infiltration: **None** Pipe Seal Cond: **Sound**
